London Borough of Harrow

Mill Farm Estate

Report

**A Risk Assessment and Structural Survey of
Non-Traditional Housing
At Mill Farm, Harrow**

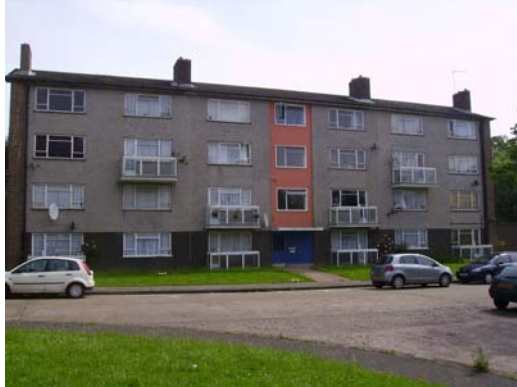
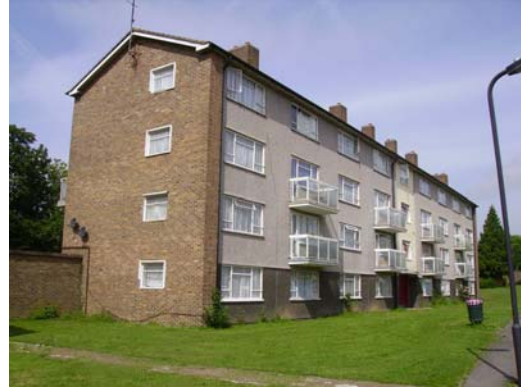
3.1 Laing Easiform

Inspection within the roof space of one of the maisonettes revealed the roof to be of timber construction, comprising primary roof trusses along with cut timbers. The condition of the timbers was noted to be reasonable and no signs of deterioration or decay could be detected. The original concrete roof tile covering appeared to be in good condition and free from defects where inspected. Loft insulation was present and was recorded to be approximately 100mm thick.

Closer inspection of the party wall within the roof space revealed that the construction was of Easiform dense concrete, so noted because of the characteristic horizontal shutter marks at approximately 600mm intervals. The condition of the wall was seen to be good and no signs of deterioration, or that it had been breached, could be determined in the area inspected.

The external components to each flat block were identical. The fascia and bargeboards were noted to be of timber and were exhibiting signs of general decay. Soffits were a cement type board and were seen to have become displaced and were generally uneven. Some localised repairs had been carried out to the soffits. Rainwater goods were in the most part PVCu and appeared to be in poor condition.

The external wall coatings comprised spar dash render to the front and rear elevations from first floor level up to top floor level. Generally, the condition of the render was noted to be weathered, although no delamination from the external wall face could be ascertained.

It was noted that the ground floor elevations had a rough cast render finish which seemed to be older and more weathered than the render to the remaining elevations. It was unclear if this was an aesthetic feature, or if a new render coat had been applied to the upper floors. The front and rear elevations to the stairwell sections exhibited a smooth cast render coat which was found to be cracked and crazed.

Some vertical cracking was noted, mainly to the rear elevation of some the blocks; in one instance, this started at the base of the rear wall and progressed up to eaves level. These cracks, however, appeared to be historic and could not be located at the corresponding position internally where inspection was feasible. Vertical expansion joints were noted to the front and rear elevations at intermediate positions along the external walls, and these were seen to be sealed with mastic.

Horizontal cracking/banding was noted to the front and rear elevations at the position of the concrete floor slabs at each floor level. However, the horizontal banding at approximately 600mm intervals, which traditionally tend to be associated with Easiform construction, could not be detected.

The appearance of the masonry gable walls would suggest that they were free from any serious structural inadequacies. No signs of any appreciable frost damage, lateral movement or bulging were noted. Some cracking was evident although very minor in its nature and, accordingly, unlikely to be conducive of any significant structural movement. In addition, the mortar appeared to be generally robust, although isolated areas of powdery mortar were noted. Consequently, it is thought that the brickwork will need to be raked out and re-pointed in places. The damp proof course at the base of the brickwork elevations was seen to be a bitumen product and was noted to be suffering from deterioration in some instances.

Although no inspection within the cavity was feasible during the site inspection, we are of the opinion that the external walls have not received cavity wall insulation due to the lack of pump holes in the render. We were unable to confirm the condition of wall ties although, due to the age of the properties, it is likely that these will require replacement in the near future.

The condition of the balcony walkways to the rear and stub balconies to the front elevations seemed to be generally good. Instances of spalling concrete and exposed reinforcement to these components were limited and they appeared to have been regularly coated with masonry paint (unknown if anti-carbonation paint has been used). Nevertheless, some minor instances of spalling concrete had occurred, particularly within the vicinity of the slab edge, the underside of the slab and around the point of the fixing for the steel guardrails, possibly as a consequence of low cover to the reinforcement.

The condition of the asphalt surface coverings to the balconies etc have deteriorated to such a level that these will soon need to be renewed; these exhibited bubbling especially to the vertical face of the slabs. The steel guardrails appeared free from any appreciable corrosion and as such should require little more than routine maintenance. However, it may be necessary to undertake some repairs to the fixings where they were secured to the slab. It should also be noted that the timber components of the guardrails have suffered decay and should be replaced. Balcony slabs to the ground floor dwellings were seen to have rotated away from the face of the building in many instances, suggesting that they were probably on a separate foundation to the main flat blocks.

Other concrete components included window cills, window surrounds (only present to the gables of the larger blocks and to the front and rear of the stairwell sections) and entrance door canopies. Spalling concrete and exposed reinforcement was generally evident to these components. In many instances the cill or the complete surround had spalled away. Some door canopies have also suffered heavy spalling, especially to the front corners where large areas of reinforcement have been exposed.

The visual evidence indicates that there are currently no major structural matters that need attention and that it is unlikely that any extensive structural remedial measures will be needed during the next 30 years. However, we would recommend that, as a minimum, allowances are included for isolated render/concrete/brickwork repairs, random reinforcement repairs together with wall tie replacement and remedial works to ground floor balcony slabs. Furthermore, we consider that the life of the dwellings will be extended well beyond 30 years if the external envelope is protected with insulation and render. The reinforcement in this type of non-traditional construction is usually in a good condition at present and overcladding the dwellings would ensure that this remained so. We would recommend external insulation which will keep the outer leaf dry in preference to cavity fill as this can cause an acceleration in the deterioration process as the outer leaf is now subject to more extreme temperature and moisture ranges than before. In terms of overall environmental improvements and benefits to residents there is merit in considering the application of external wall insulation. This will enhance and prolong the life of the structural wall components beyond the 30 year time frame considered here and, thus, we have shown this item of work together with an allowance for wall tie replacement and general concrete repairs etc. as the recommended option.

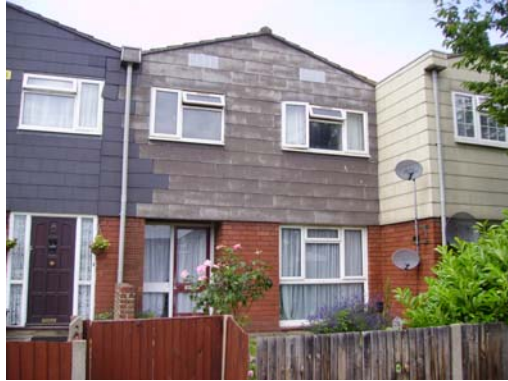
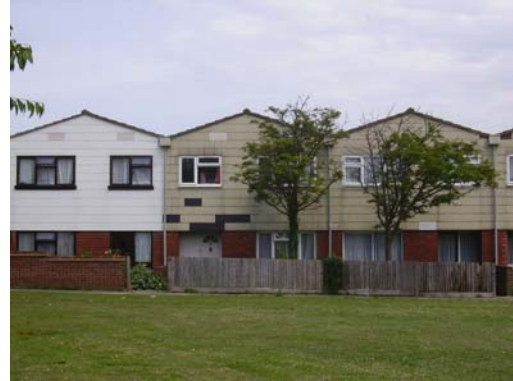
3.2 Timber Frame Houses

These were seen to be two storey terraced houses with pitched roofs located in Miller Close.

It is considered that these properties are in original condition and have not received any notable refurbishment/repair works, apart from the provision of PVCu windows and reactive maintenance repairs to the external tile hanging.

Inspections within the roof space revealed a timber trussed roof construction which was seen to be in good condition, although the low pitch of the roof made entering the roof space infeasible. Underfelt was present and the condition of the interlocking concrete roof tile covering was found to be reasonable. Loft insulation was noted to be approximately 100mm thick.

The external walls comprised a brickwork outer skin to the ground floor elevations and artificial slate tile hanging to the first floor. The brickwork was noted to be in good condition and no instances of cracking were evident. Similarly, the mortar joints, where examined, seemed robust and no instances of soft/ powdery mortar could be identified. Much of the tile hanging to the first floor was in poor condition, with many instances of damage having occurred through lack of maintenance and vandalism. Where seen, the sarking felt was noted to be weathered and damaged in the position of broken tiles. The tile hanging to many of the properties appeared to have been completely replaced with new materials.

Fascias and soffits were not present to the properties and PVCu rainwater goods were noted to be in a generally poor condition.

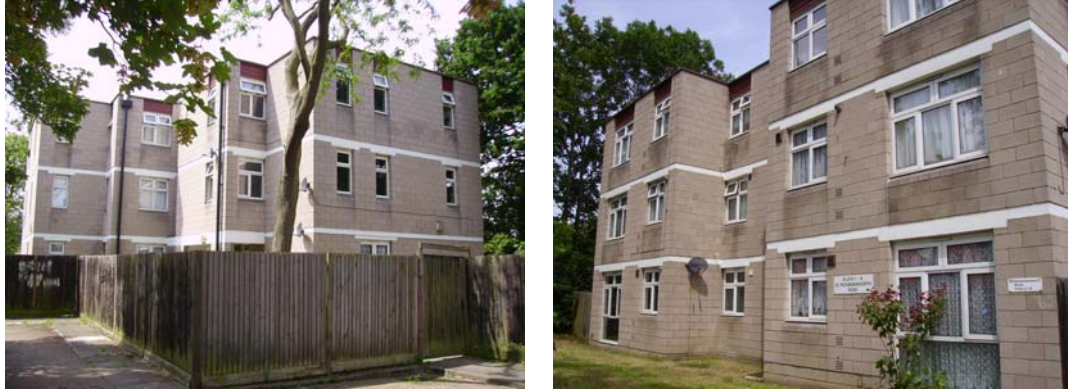
3.3 Unknown

This block of nine flats at 62 Rickmansworth Road was seen to be of three storeys with a flat roof.

No inspection was feasible to the flat roof covering at the time of the inspection and, therefore, its condition could not be ascertained. However, we were able to identify that the roof covering was felt, visible where it had been lapped over the parapet.

The external leaf of masonry comprised feature concrete blockwork (395x190x190mm) which was generally free from defects, cracking etc. Some minor vertical cracking was noted to the rear of the property in the vicinity of some recently completed excavations/earthworks. The mortar joints to the blockwork also seemed generally robust with no visible areas of soft/powdery mortar. We were unable to inspect within the cavity at the time of the inspection and, consequently, the condition of any wall ties present could not be ascertained. We suspect that cavity wall insulation has not been introduced as no pump holes could be located on any of the elevations.

PVCu rainwater goods appeared to be in good condition.

The exposed edges to the concrete floor slabs which incorporate lintel details above openings, appeared to be largely free from any potential defects - there was little visible evidence of any concrete having cracked and/or spalled as a consequence of corroded reinforcement. The exposed floor slab was seen to be coated in masonry type paint, which was in good condition with no occurrences of de-bonding visible. The joint between the floor slab and the lintel was noted to be a dry joint with no mastic seal.
